**Make the Smart Choice!  
Look inside the control box and  
compare to our competitors!**

## **Most Spa Controls Are Built to Fail With a Short Life Span! Read the problems below as reported to us by consumers.**

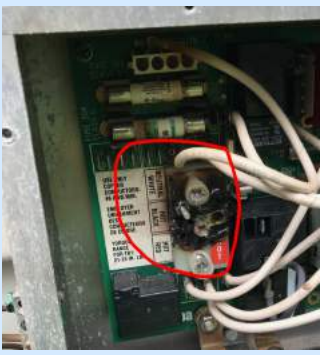
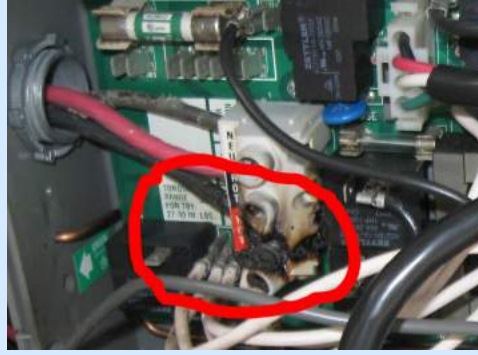
### **Problem (1): Power Terminal Block Soldered Directly on PC Board**

Typical failures occur when the incoming power is connected directly on the PC board. The PC board must be replaced at hundreds of dollars.

**Solution (1):** Installing the Power Terminal Block separate from the PC board. If the Power Terminal Block burns due to voltage fluctuations on the power line, the repair can be done by simply replacing a \$20 Power Terminal Block, not the entire PC board for hundreds of dollars.

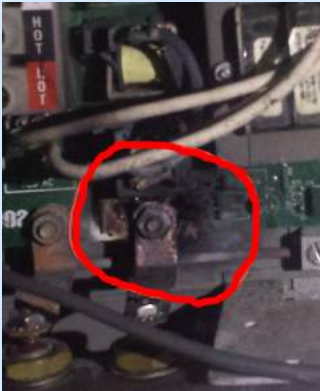
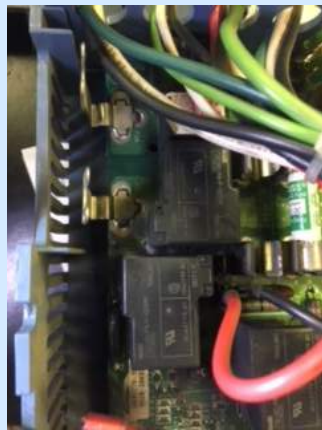
**Problem (2): Heater Load is Carried by Relays That Are Soldered Directly on the PC Board**

Typical failures occur when the heater load is directly connected to the PC board. Once again, the PC board must be replaced at high \$ cost.

**Solution (2):** Since 1984 we have used separate and heavy duty contactors to carry the ON/OFF loads of the heaters. Very seldom does a contactor fail; and if it does, since it is separate from the PC board, it only cost \$40 to replace. In addition, all relays are energized at Zero Crossing to minimize electrical spikes.

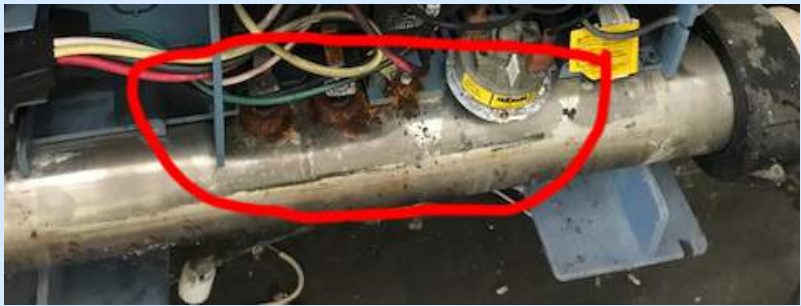
**Problem (3): Heater with Bulk-Heads and 304 Stainless Steel Manifold**

Typical failures occur on this style of heater with bulk-heads where the bulk-heads are braised or welded or crimped and epoxied and the heater manifold is made out of 304 stainless steel.

**Solution (3):** Our patented CosmoHeat with O-ring seals, no bulk-heads, no braising, no welding, no crimping, no epoxy and no 304 stainless steel manifold. [Click to see why our bulk-head free heater is the best.](#)

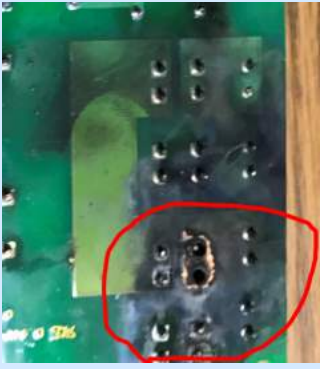
**Problem (4): Over-Loaded Single Common Power Relay**

Typical failures occur when operating two pumps on a single common relay soldered on the PC board. The common relay cannot carry both inductive loads for very long.

**Solution (4):** We use two separate common relays to operate two water pumps. In addition, all relays are energized at Zero Crossing to minimize the peak load from the motor on the relay contact points.

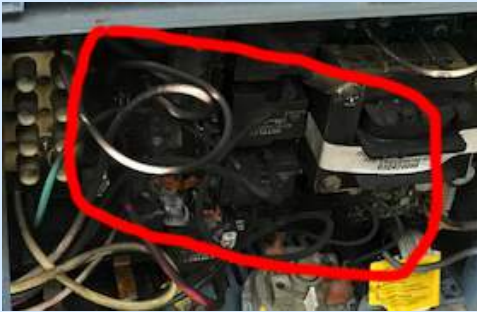
**Problem (5): Crowded Circuitry to Reduce Size and Cost**

Control circuitry is too crowded. Not enough real estate inside the Control Box with too many wires.

**Solution (5):** All our circuit traces on the PC boards are properly separated at  $\frac{1}{8}$ " between the AC and DC power lines. We use the proper gauge wires for all circuit loads. All wires that carry AC Power Signals are separated from DC signals on the PC Board to minimize noise and odd software logic glitches. In addition, we maintain a proper ground bus throughout the entire control box.
