**Make the Smart Choice!
Look inside the control box and compare to our competitors!**

Most Spa Controls Are Built to Fail With a Short Life Span! Read the problems below as reported to us by consumers.

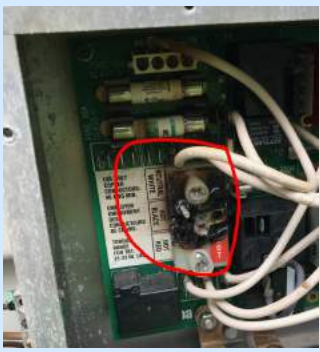
Problem (1): Power Terminal Block Soldered Directly on PC Board

Typical failures occur when the incoming power is connected directly on the PC board. The PC board must be replaced at hundreds of dollars.

Solution (1): Installing the Power Terminal Block separate from the PC board. If the Power Terminal Block burns due to voltage fluctuations on the power line, the repair can be done by simply replacing a \$20 Power Terminal Block, not the entire PC board for hundreds of dollars.

- 16 - The USC Power Terminal Block is not mounted on the PC Board minimizing PC Board failure due to brown out, voltage drop or electrical fluctuations on the line.

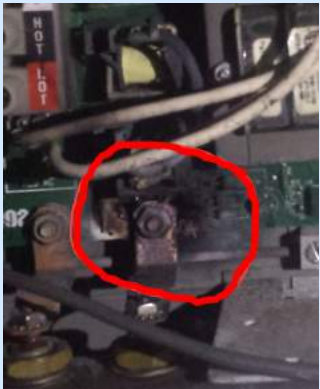
Problem (2): Heater Load is Carried by Relays That Are Soldered Directly on the PC Board

Typical failures occur when the heater load is directly connected to the PC board. Once again, the PC board must be replaced at high \$ cost.

Solution (2): Since 1984 we have used separate and heavy duty contactors to carry the ON/OFF loads of the heaters. Very seldom does a contactor fail; and if it does, since it is separate from the PC board, it only cost \$40 to replace. In addition, all relays are energized at Zero Crossing to minimize electrical spikes.

- 15 - USC is equipped with a Contactor mounted off the PC Board. This diverts the heater resistive load away from the PC Board extending its longevity.

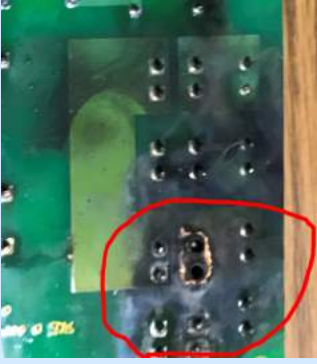
Problem (4): Over-Loaded Single Common Power Relay

Typical failures occur when operating two pumps on a single common relay soldered on the PC board. The common relay cannot carry both inductive loads for very long.

Solution (4): We use two separate common relays to operate two water pumps. In addition, all relays are energized at Zero Crossing to minimize the peak load from the motor on the relay contact points.

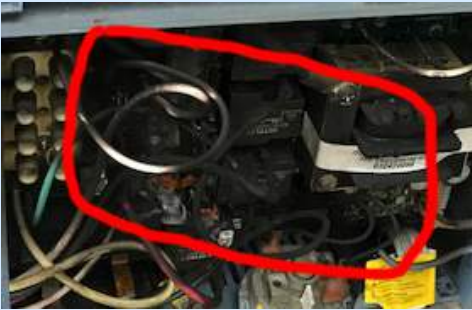
Problem (5): Crowded Circuitry to Reduce Size and Cost

Control circuitry is too crowded. Not enough real estate inside the Control Box with too many wires.

Solution (5): All our circuit traces on the PC boards are properly separated at $\frac{1}{8}$ " between the AC and DC power lines. We use the proper gauge wires for all circuit loads. All wires that carry AC Power Signals are separated from DC signals on the PC Board to minimize noise and odd software logic glitches. In addition, we maintain a proper ground bus throughout the entire control box.
